# Press information

Second wave of via ferrata set recalls within six months

## Considerable deficiencies found in many via ferrata sets

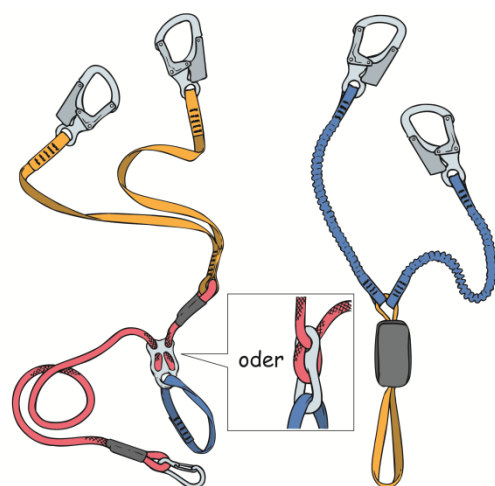
The recent recalls concern via ferrata sets employing the rope friction technology (the set on the left in the sketch). These systems can be recognized by the metal plate through the holes of which a rope is guided.

The recall in August 2012 concerned several sets with elastic lanyards and tearing energy absorber (the set on the right in sketch). The recall list now available (see below) summarizes both recalls as well as the lifetime specifications provided by the manufacturers. **The Alpine Clubs strongly**

Two types of energy absorbing systems are known – one type employs tearing energy absorbers, the other one employs the rope friction technology. Only the systems employing the rope friction technology are affected by the problem recently found. These systems use a metal plate provided with holes through which the brake rope is guided. Fall energy is compensated by the rope passing through the metal plate. Material aging, however, causes loss of the brake rope's flexibility. As a consequence, the friction in the system increases, leading to higher maximum forces acting on the energy absorbing system. At the same time, the lanyards lose strength due to use and aging. Finally, with certain via ferrata sets both effects in combination may lead to breaking in a fall situation. Due to the high significance of age and usage of the product, greatest importance must be placed on accurately observing the manufacturers' lifetime specifications.

**advise all users of via ferrata sets to check their sets on the basis of this list. Via ferrata sets affected by a recall must not be used any longer, but do have to be returned to the manufacturer. Sets which are not affected by a recall but have exceeded the lifetime indicated by the manufacturer must not be used any longer.**
